ERDC/CHL TR-01-26

# **Impacts of Navigation Channel Maintenance Dredging on the Coastal Processes of Chatham, Massachusetts**

Donald K. Stauble

September 2001

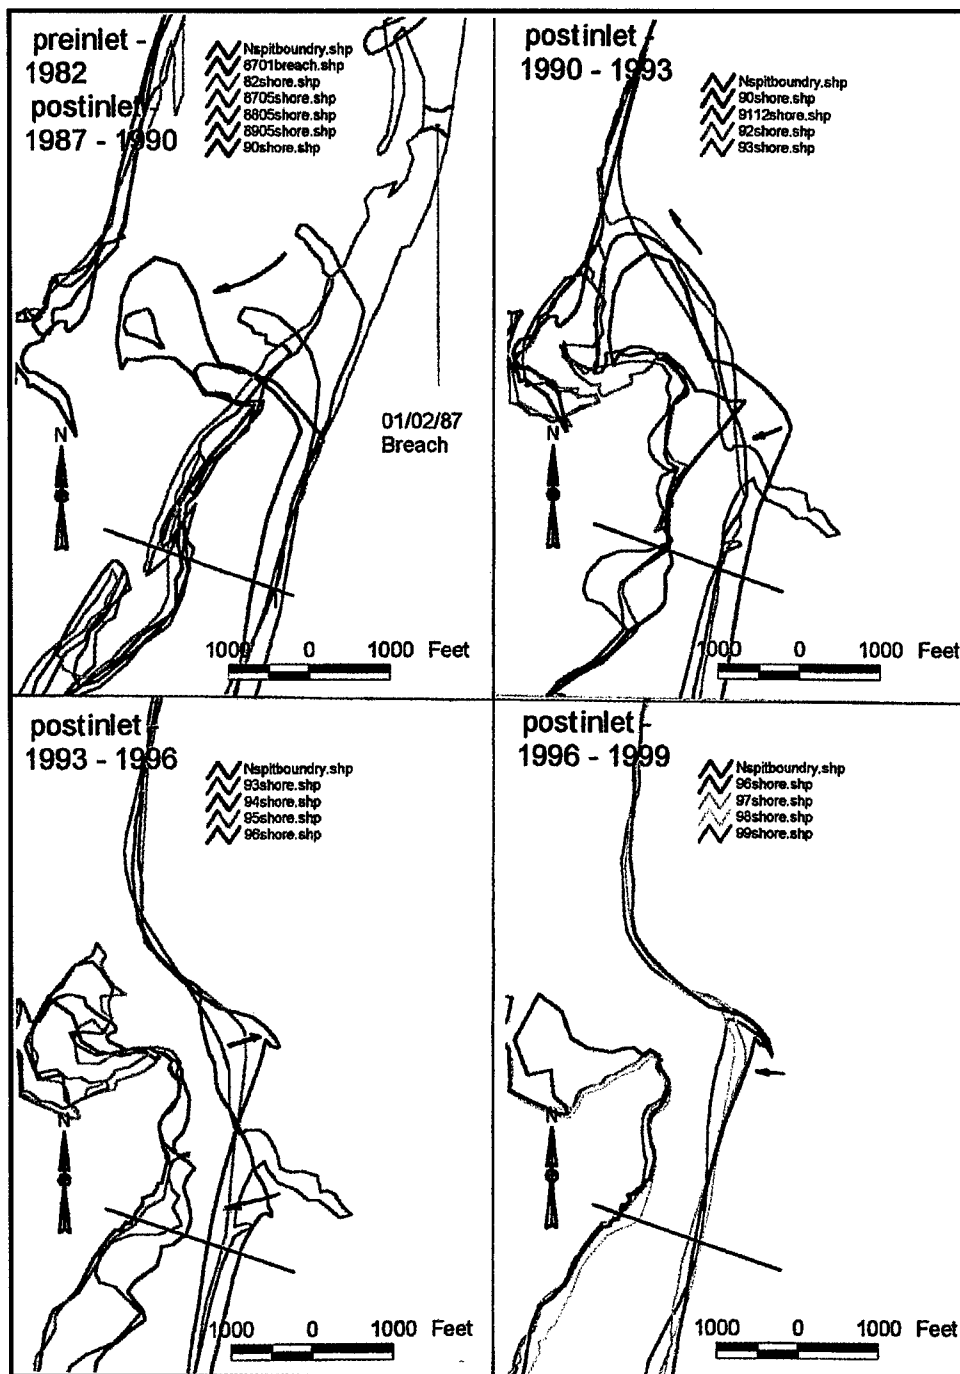
Figure 32. Map of area change to initial recurving south spit and final South Beach land bridge. Line identifies common southern limit of area measurement. Common mainland area boundary used was the 1982 dune/cliff/vegetation line

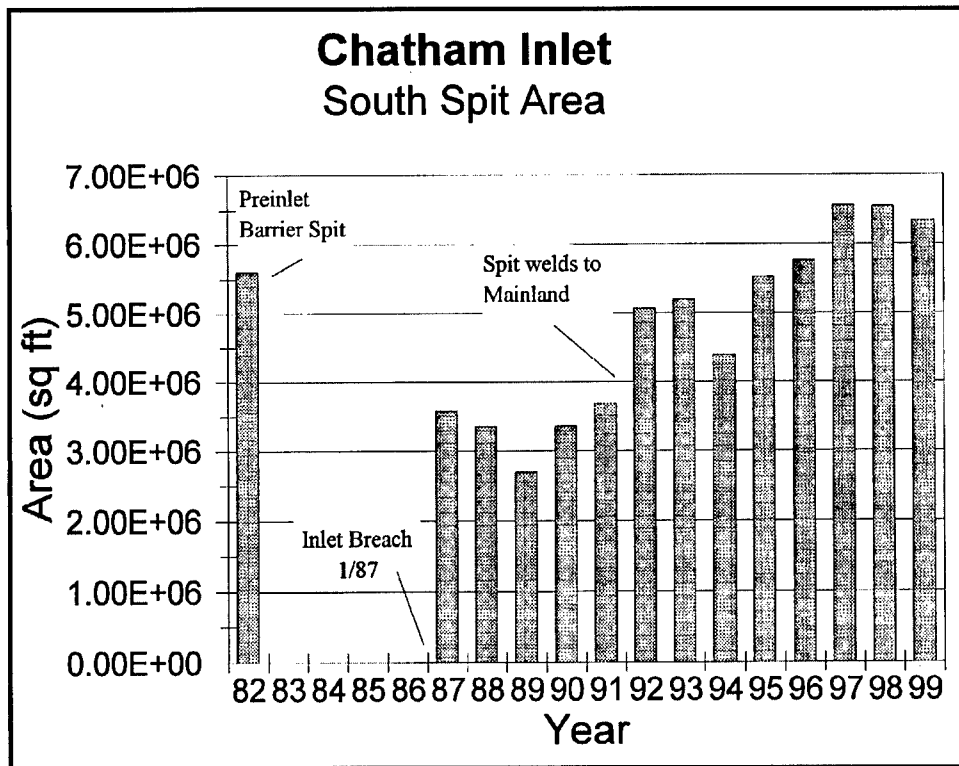
Figure 33. Area change from prebreach to 1999 of south spit/South Beach

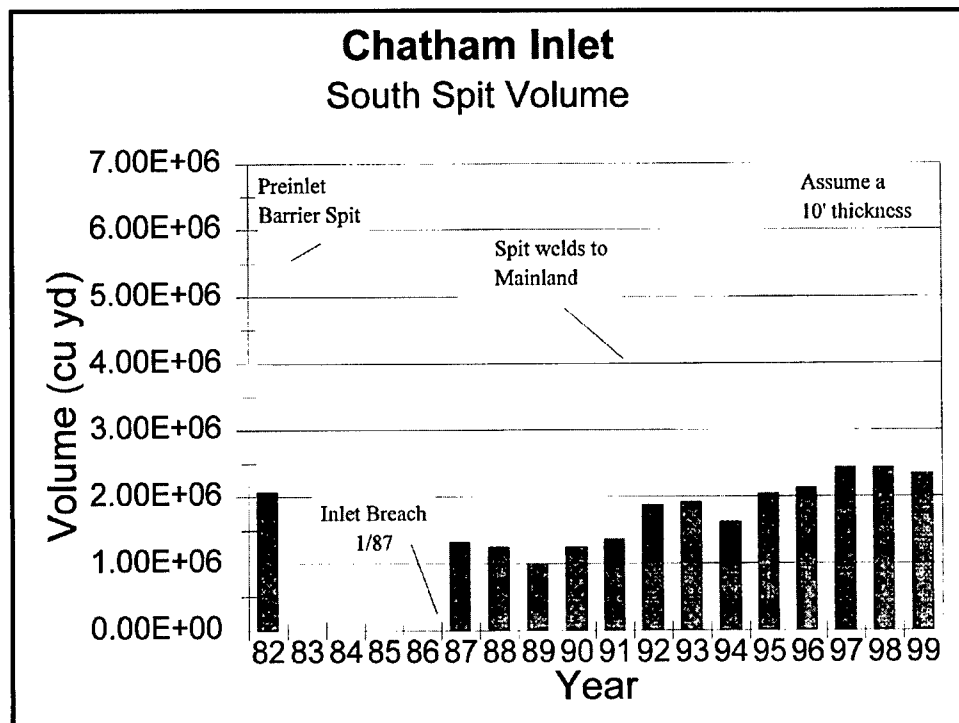
Figure 34. Estimate of volume change of south spit/South Beach

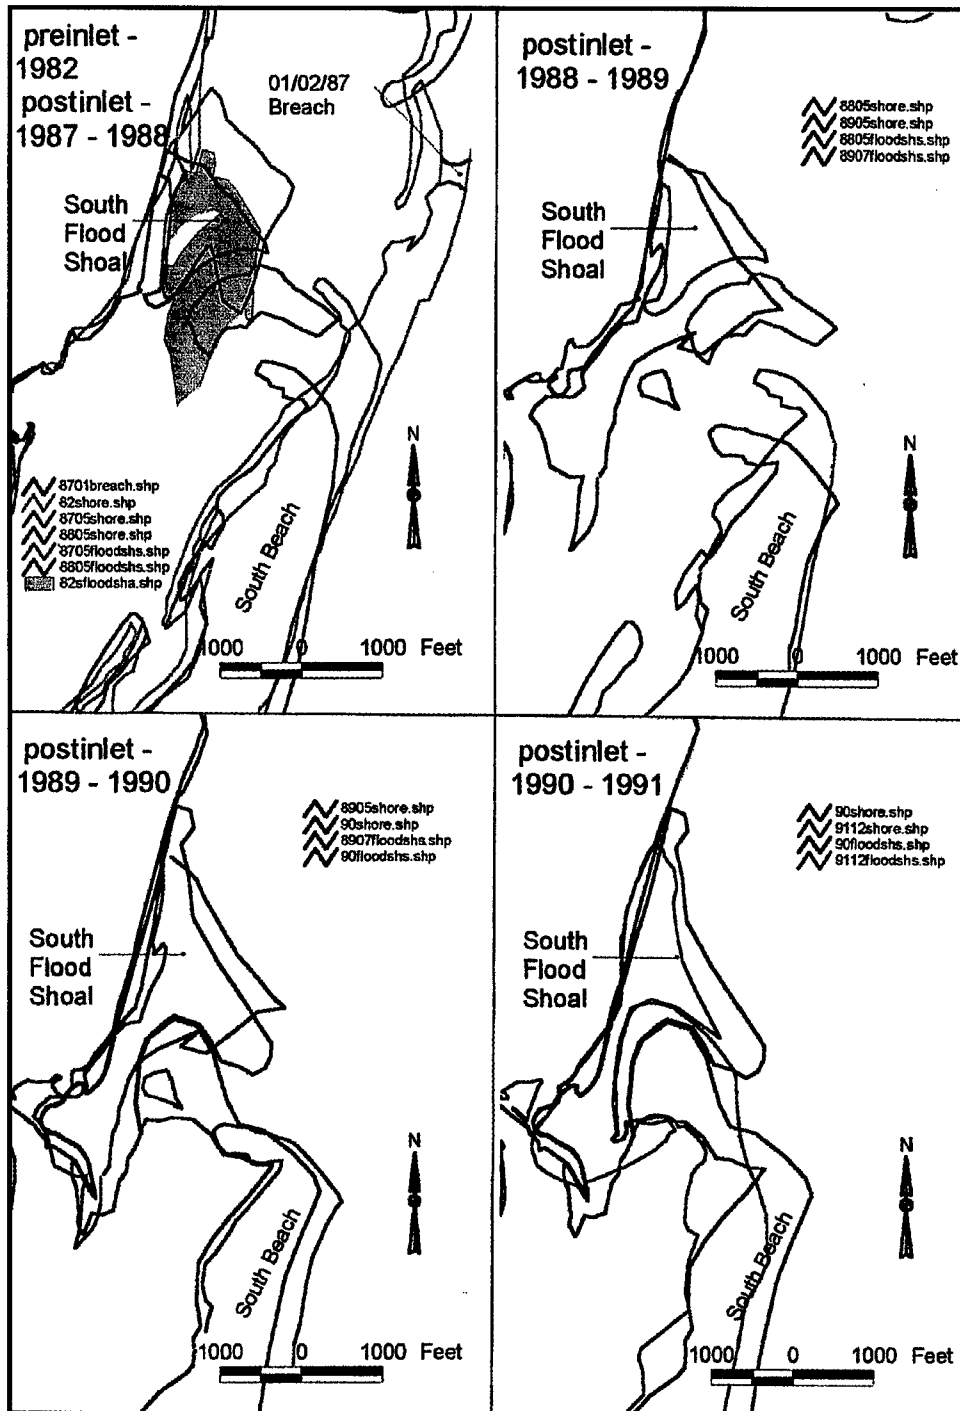
Figure 35. Map of area change to south flood shoal. Solid area shows preinlet remnant shoal that was incorporated into the south flood shoal

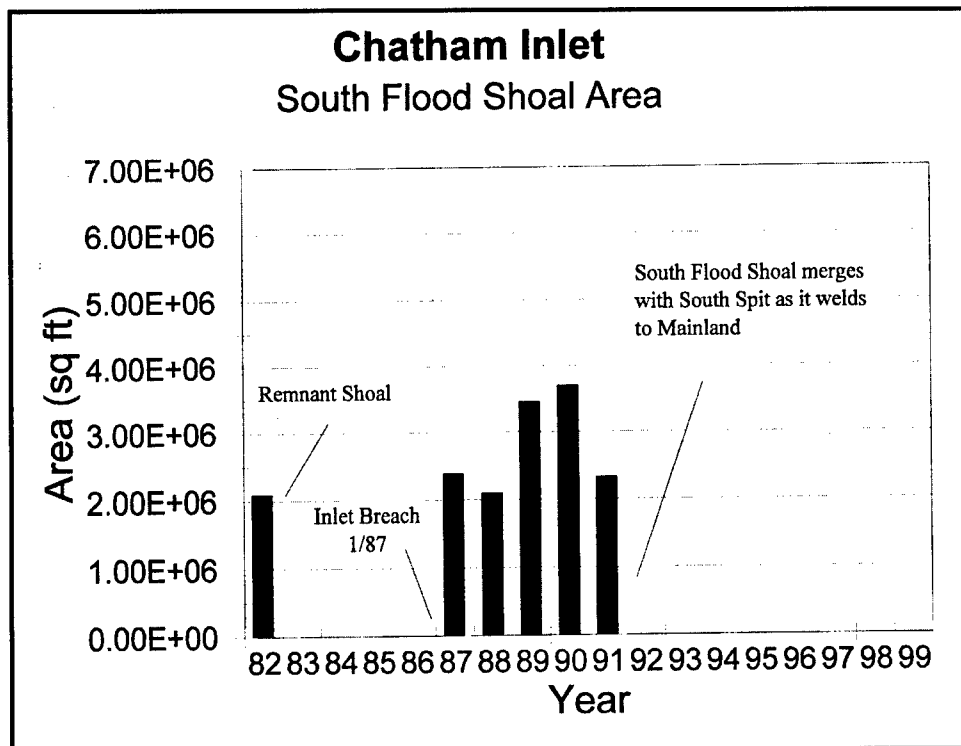
Figure 36. Area change from prebreach shoal to 1999 south flood shoal

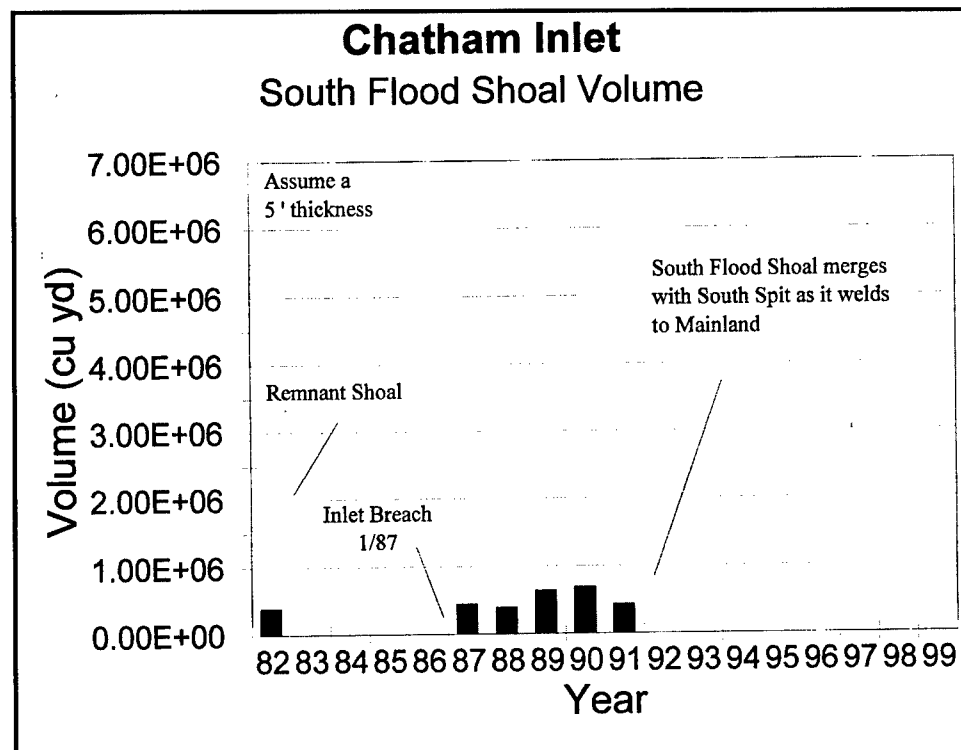
Figure 37. Estimate of volume change in south flood shoal

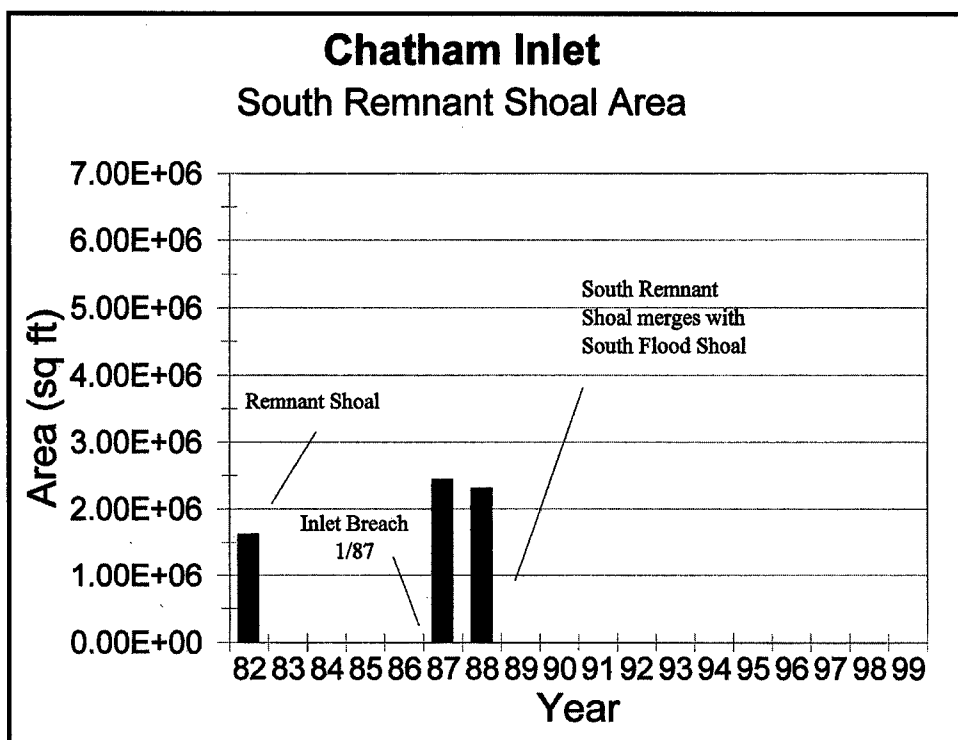
Figure 39. Area change from prebreach to 1999 to remnant south sand flat

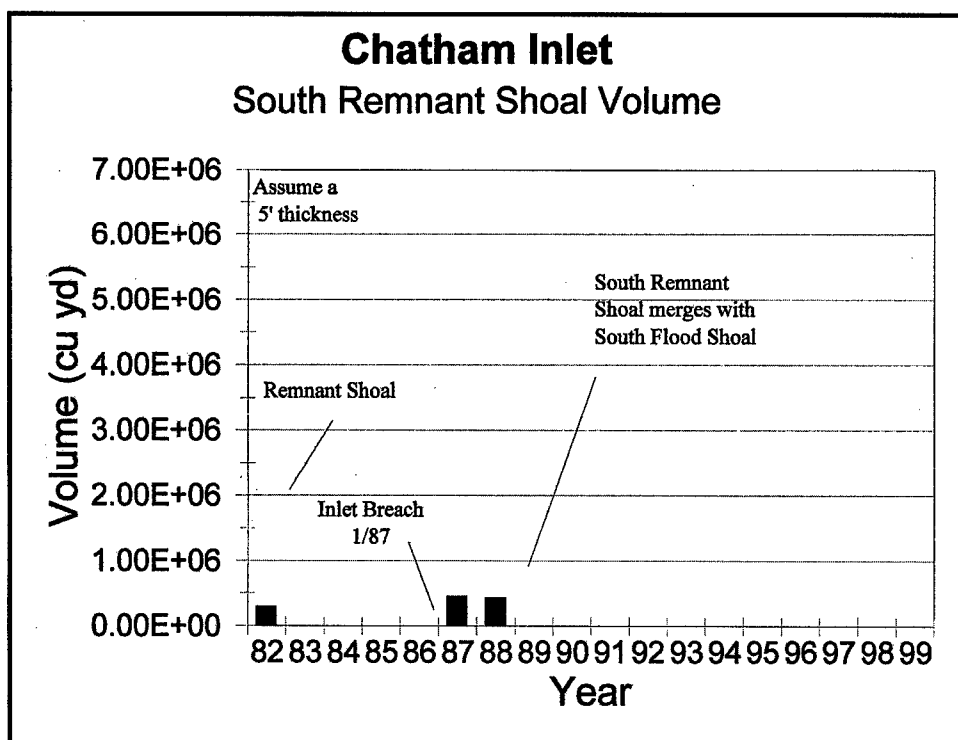
Figure 40. Estimate of volume change in remnant south sand flat

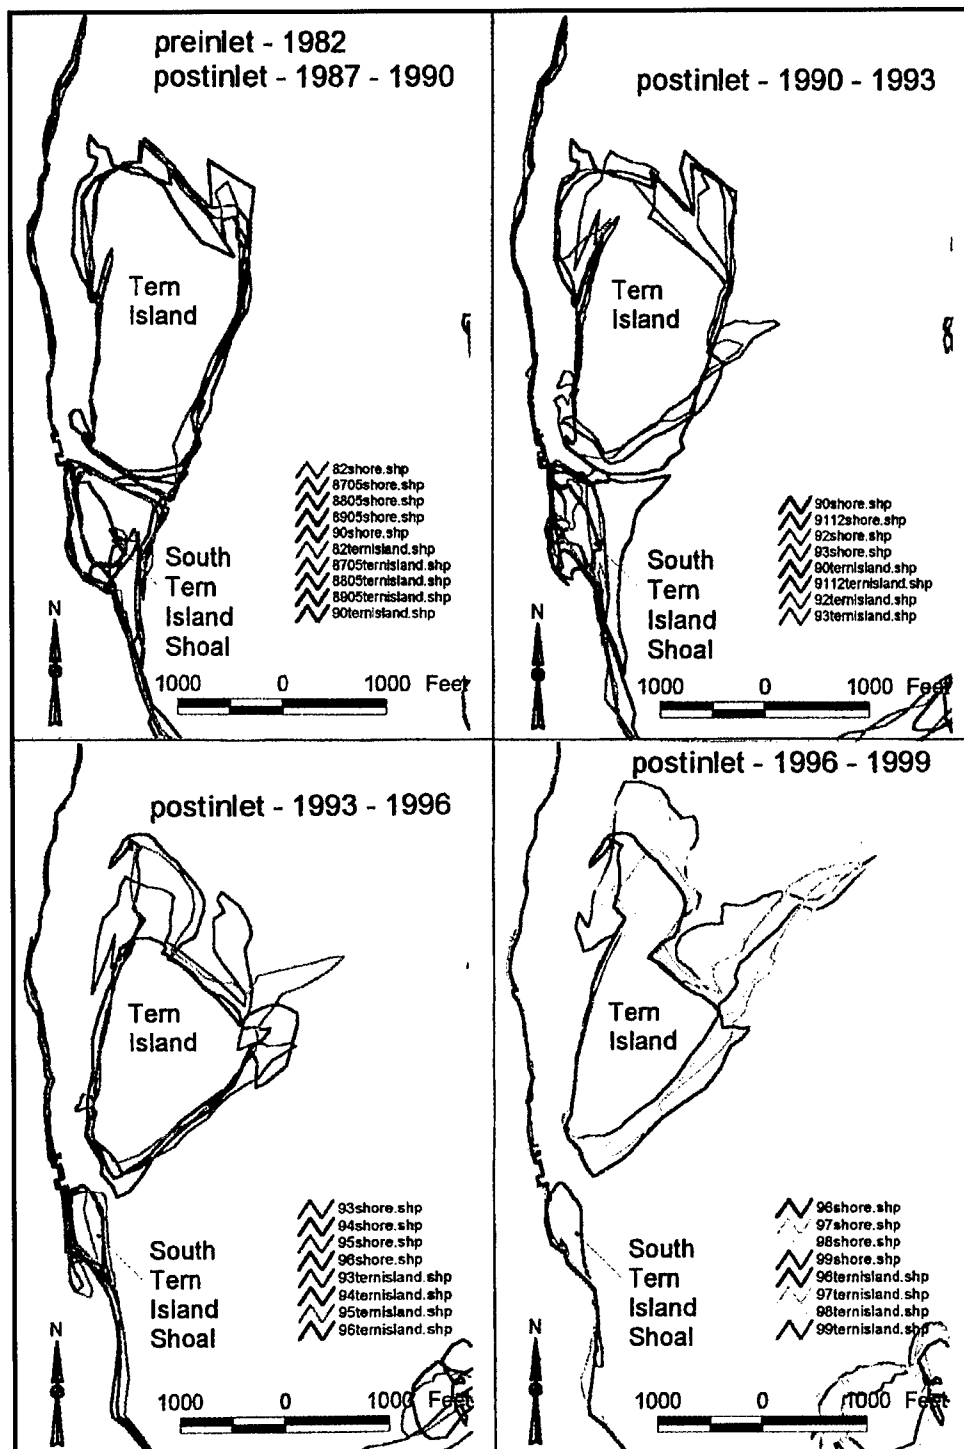
Figure 41. Map of area change to Tern Island and Tern Island south shoal

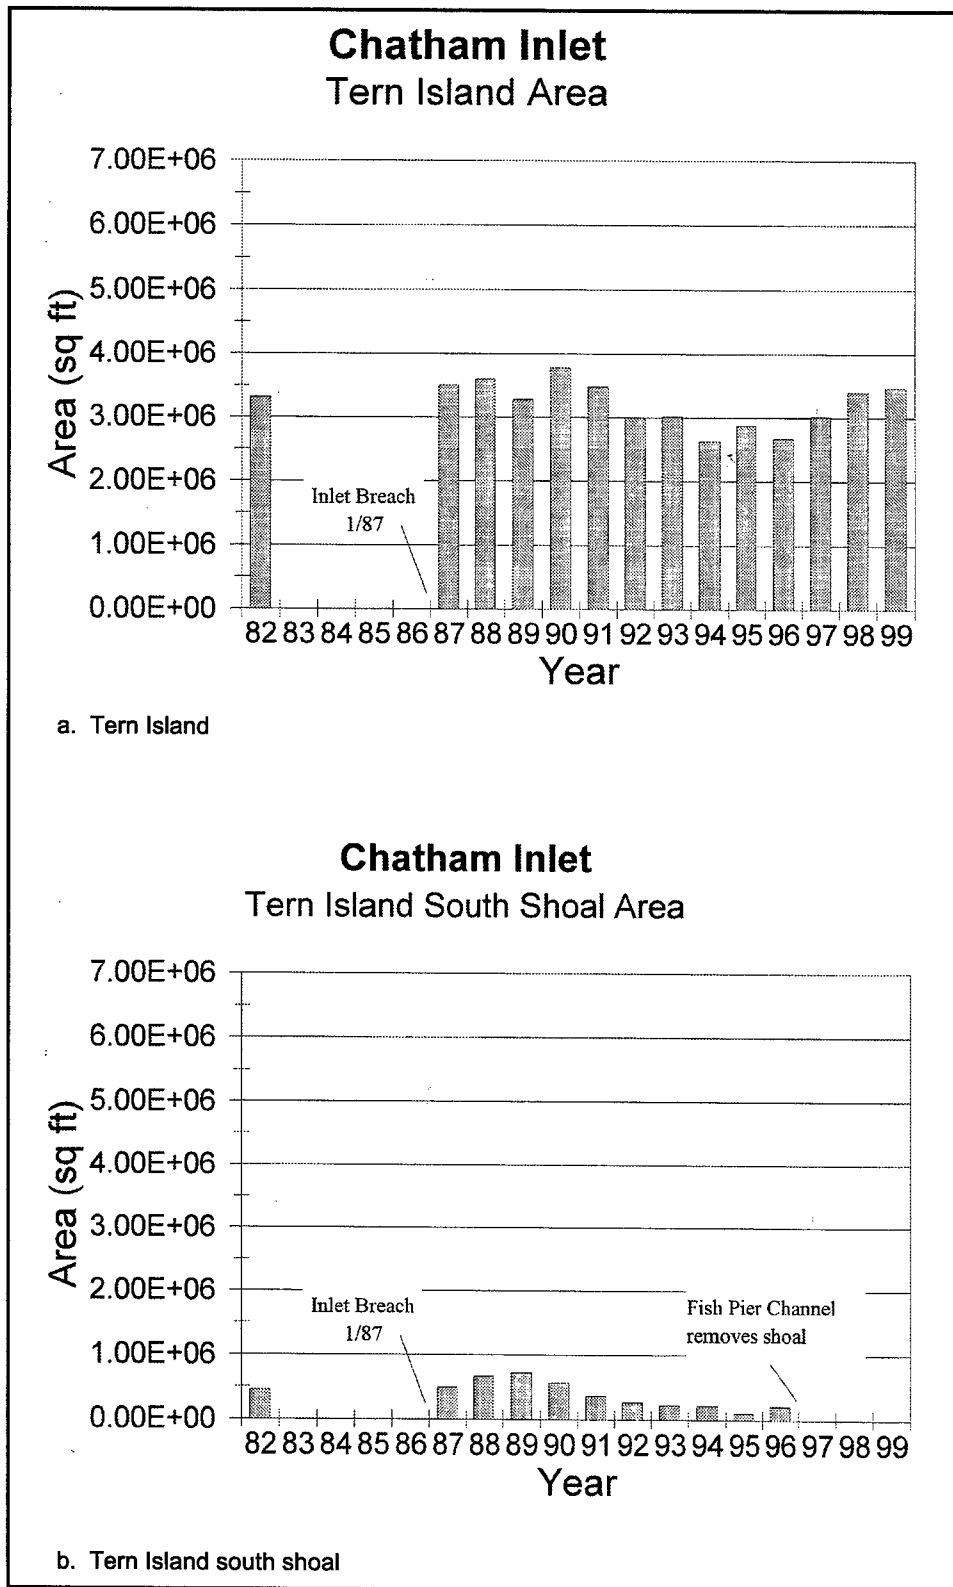
Figure 42. Area change from prebreach to end of study

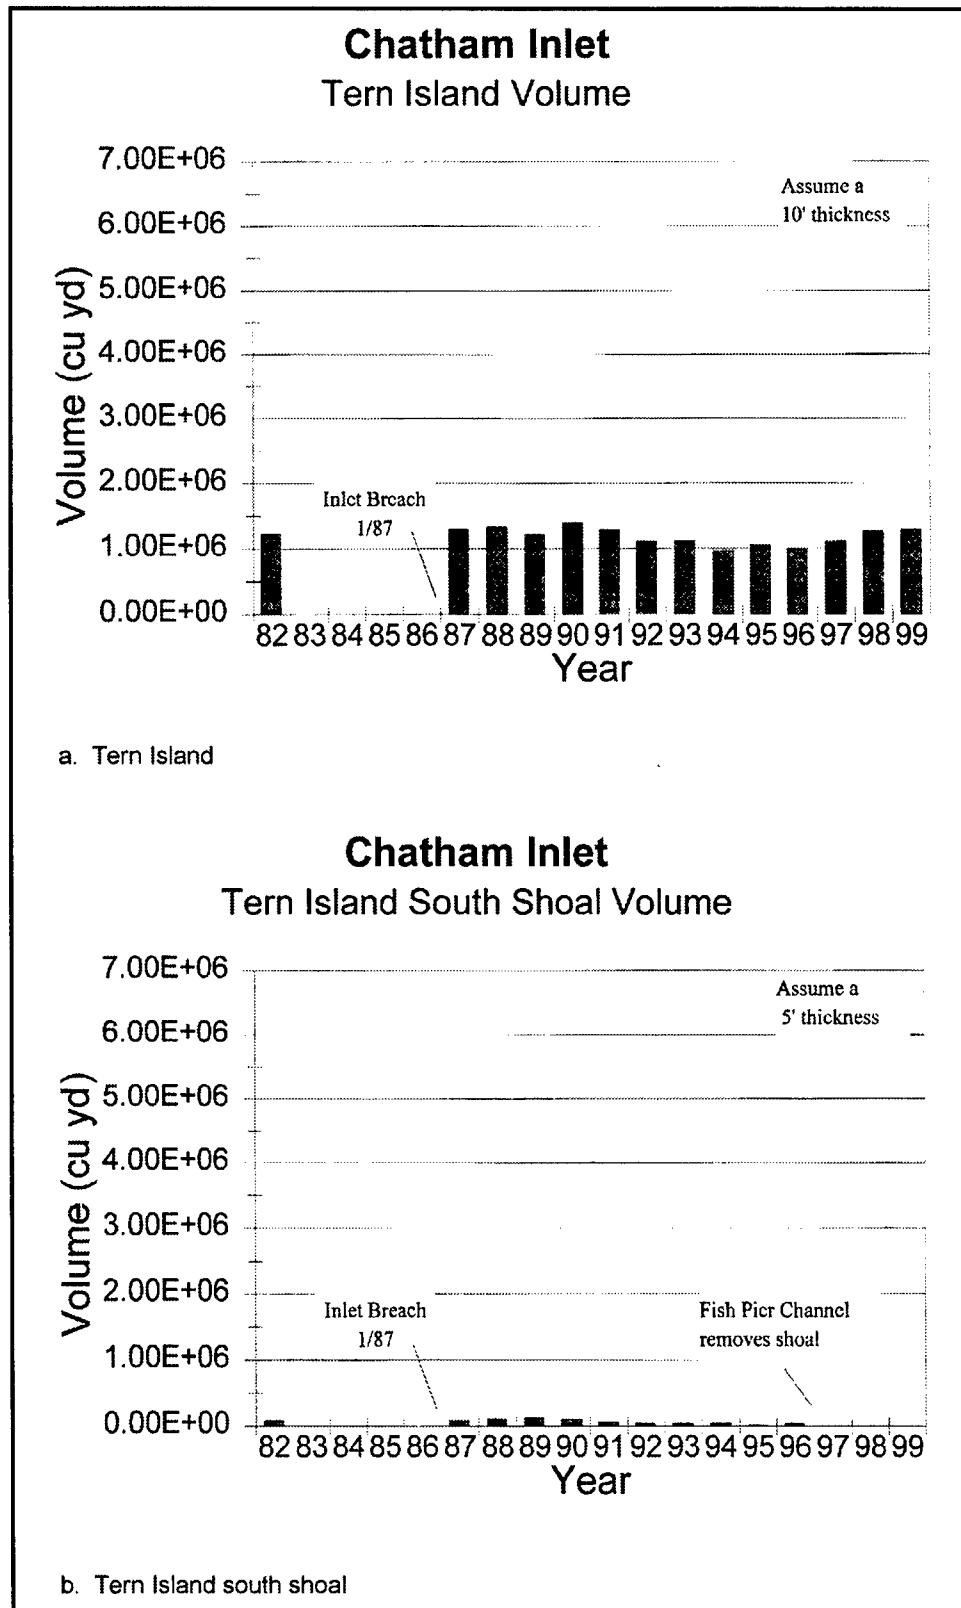
Figure 43. Estimate of volume change

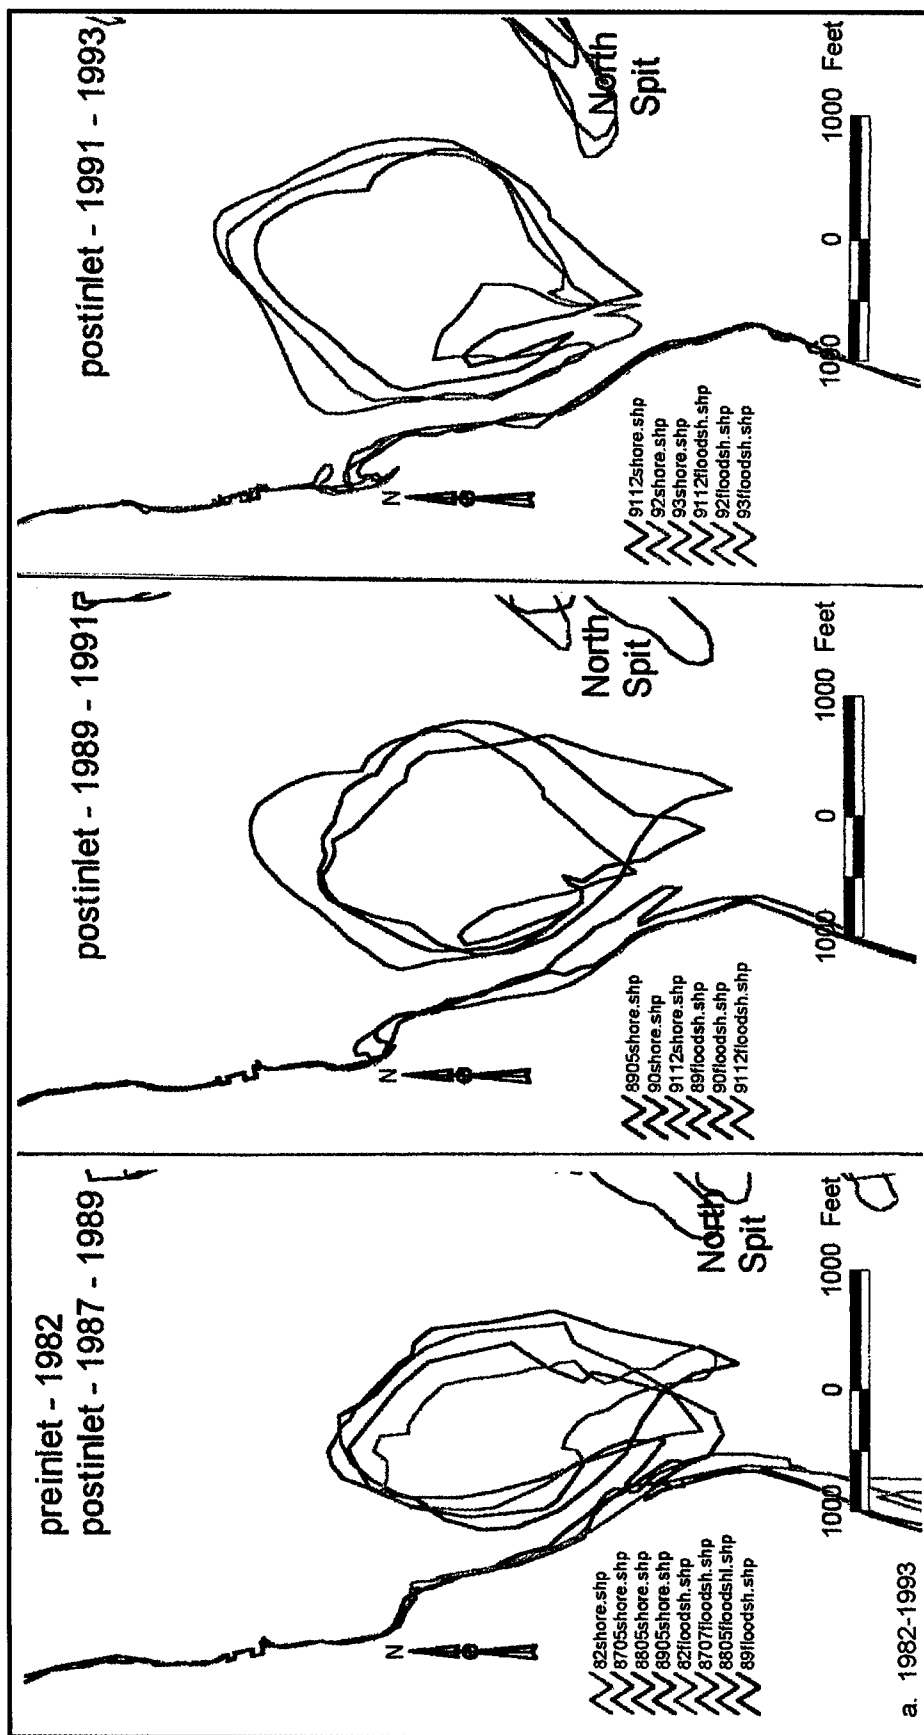
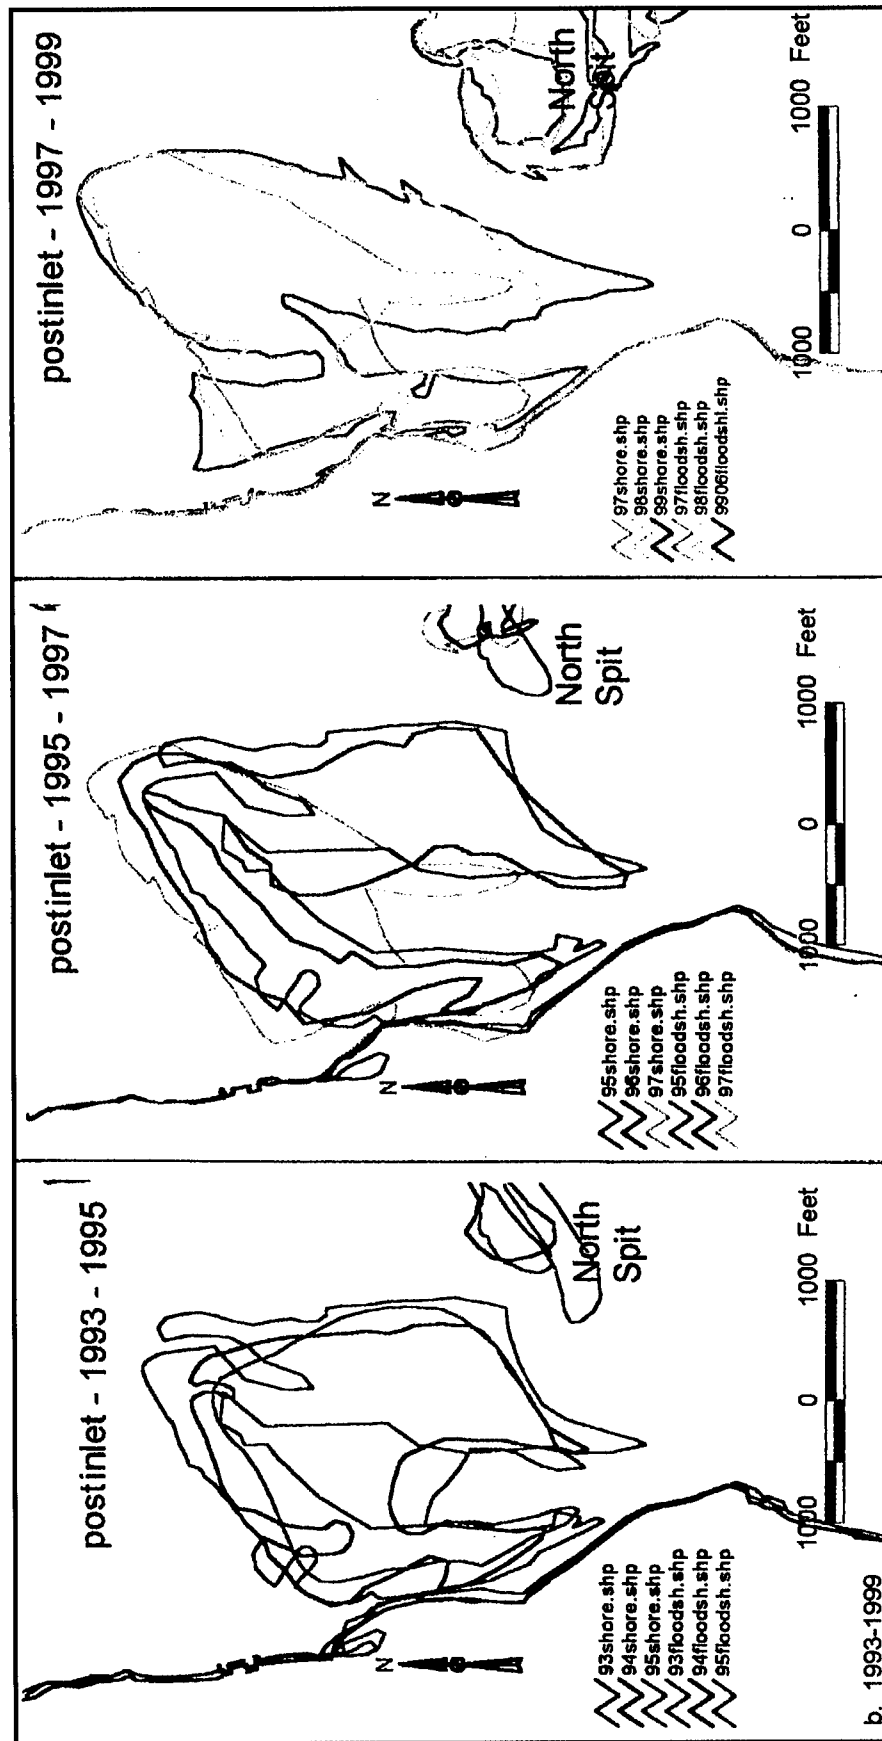
Figure 44. Map of change in north flood shoal (Continued)

Figure 44. (Concluded)

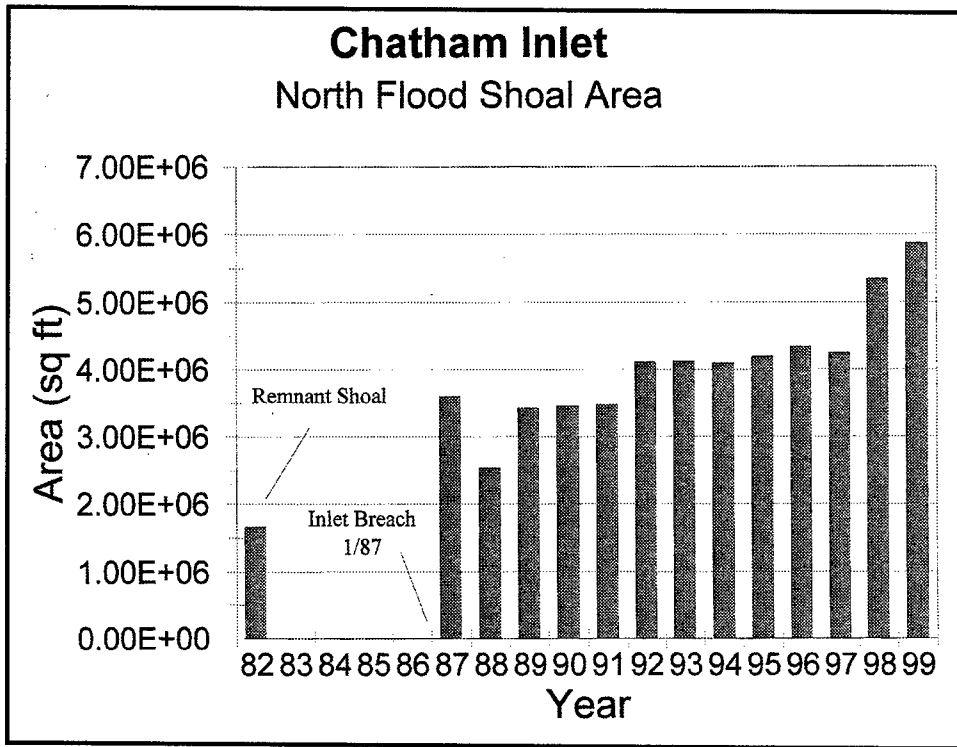
Figure 45. Area change from prebreach to 1999 in north flood shoal

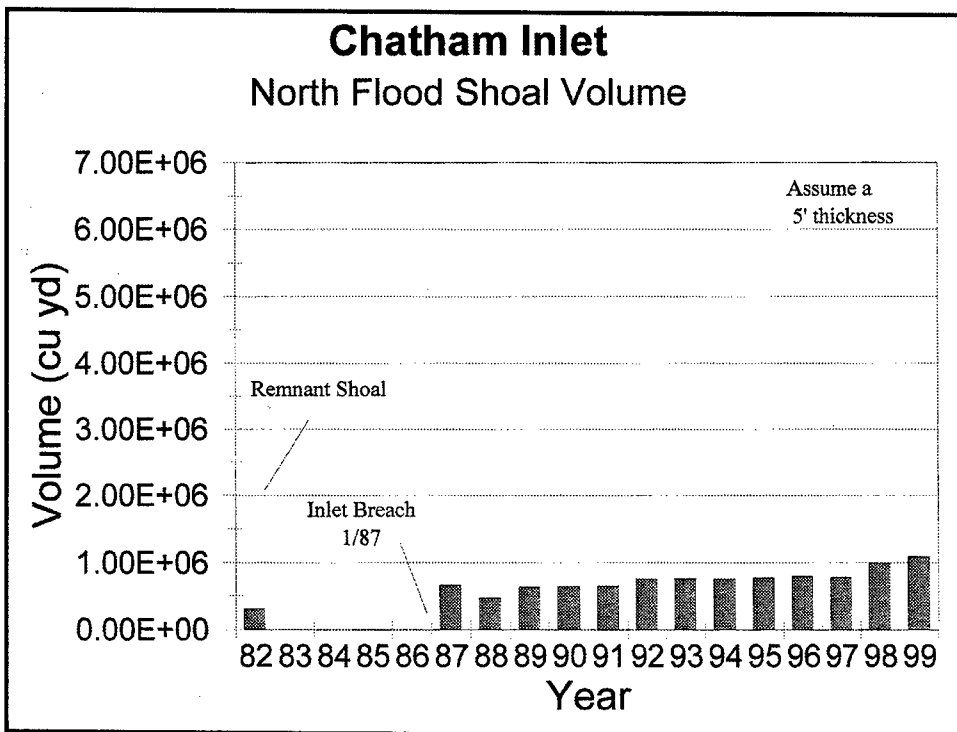
Figure 46. Estimate of volume change in north flood shoal

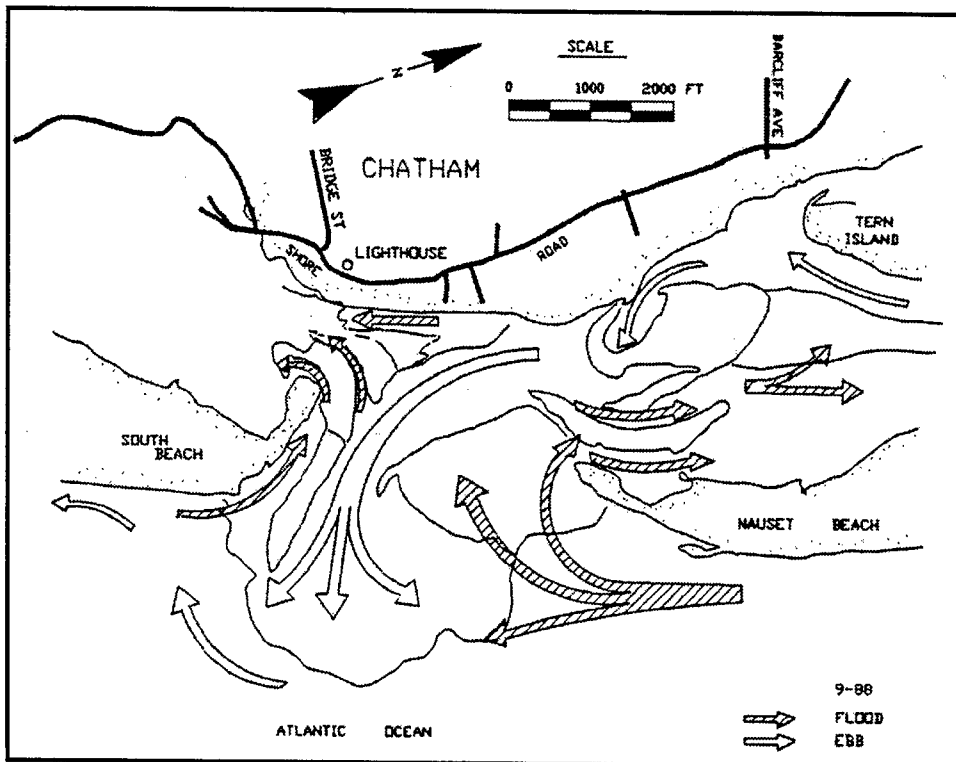
Figure 48. Sediment transport pathways at Chatham Inlet based on morphology from September 1988 (Liu et al. 1993)

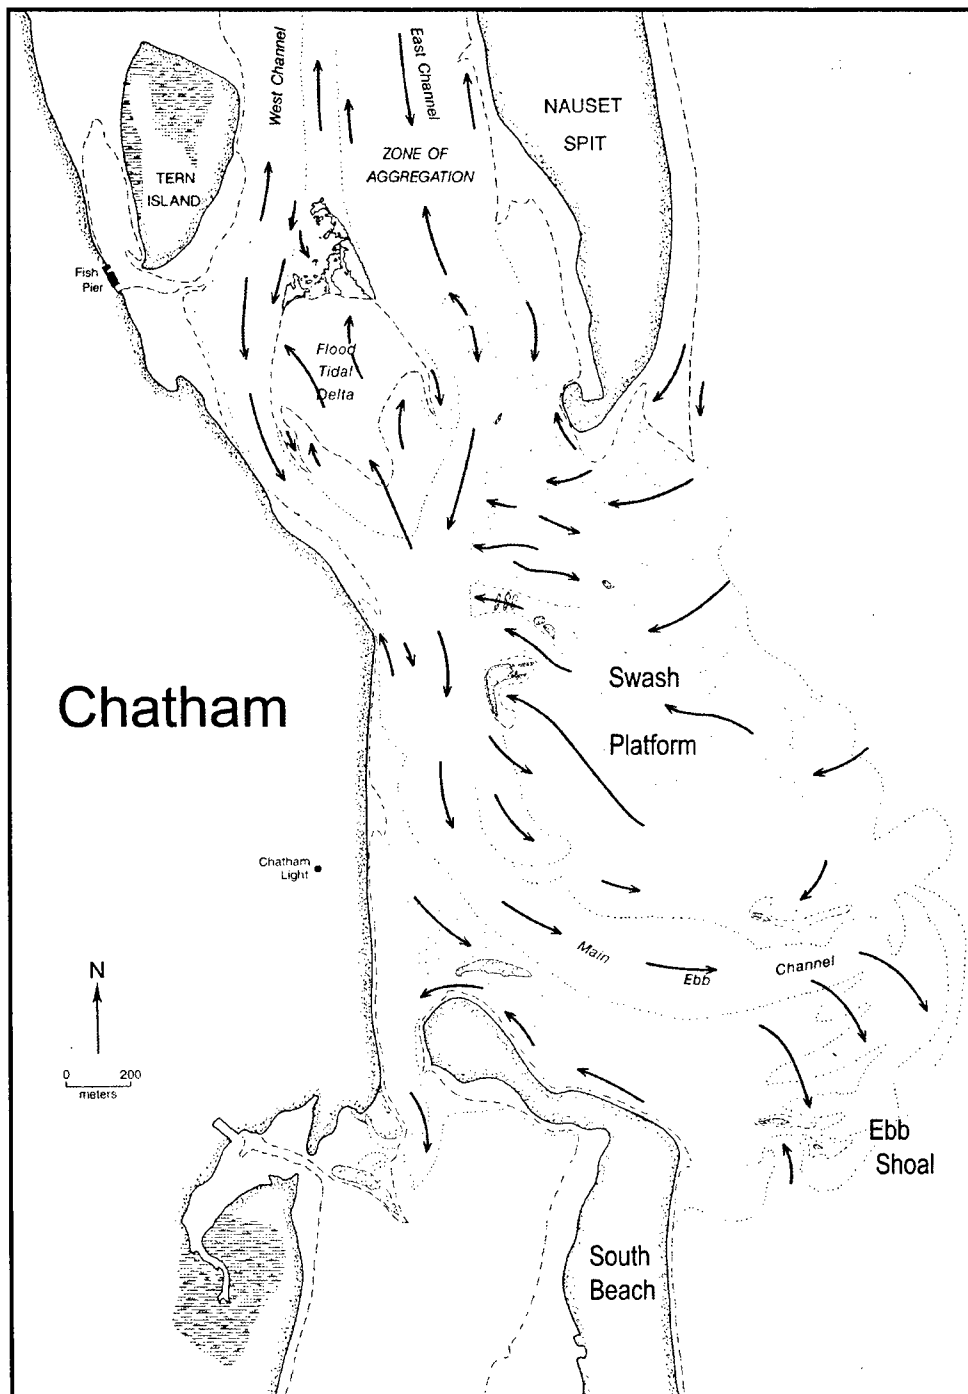
Figure 49. Detailed sediment transport pathways from summer 1990 (after Fitzgerald and Montello 1993)

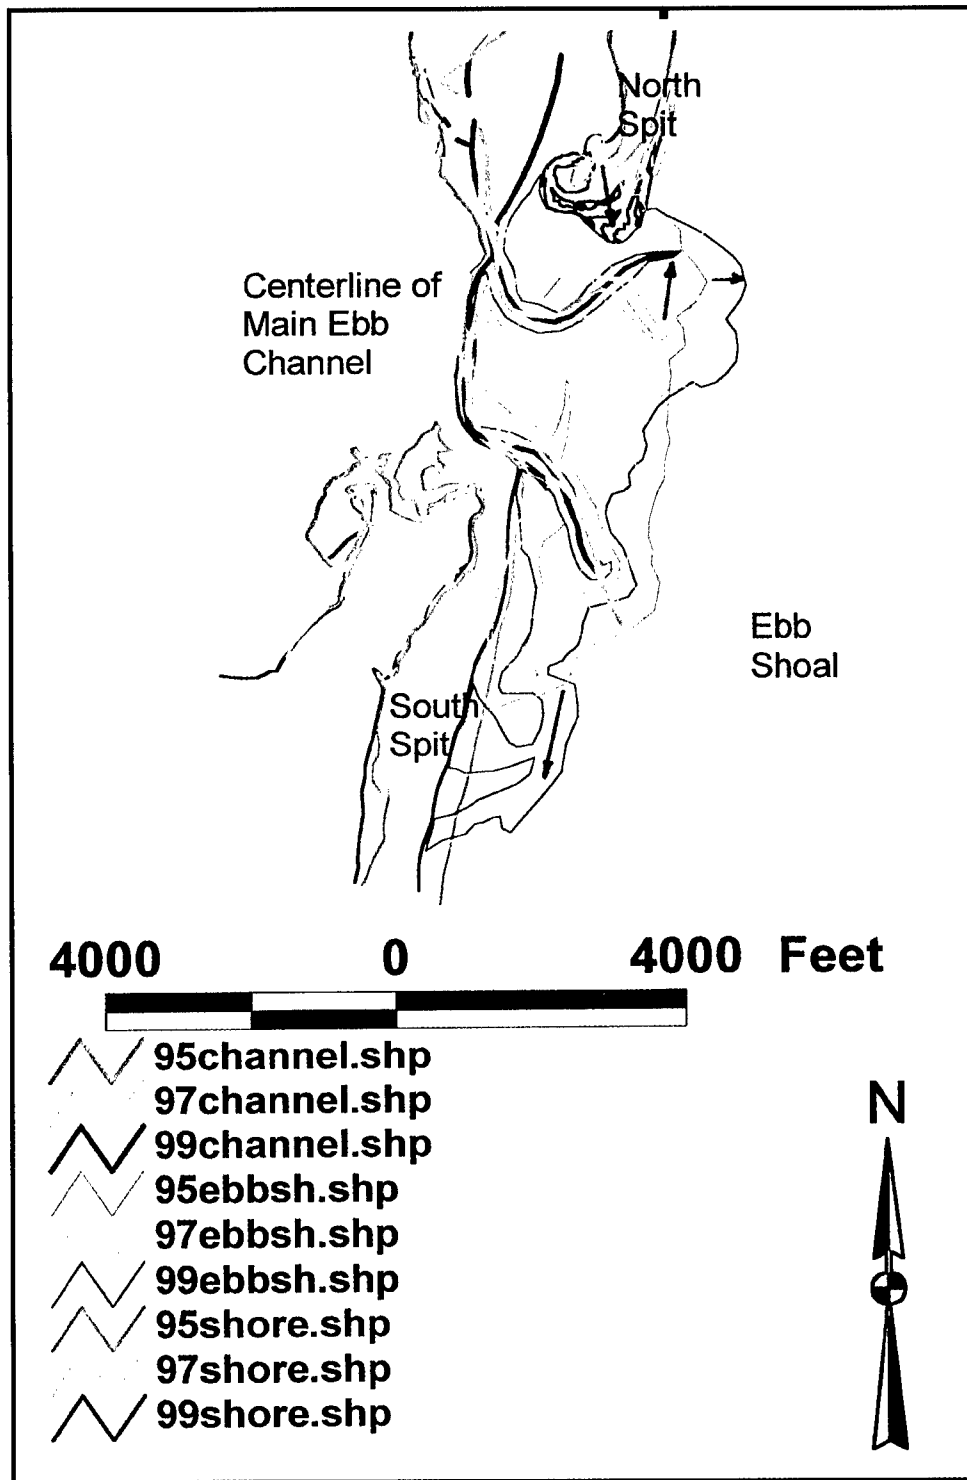
Figure 52. Net changes in main ebb channel, ebb shoal edge, and north and south spits from 1995 to 1999

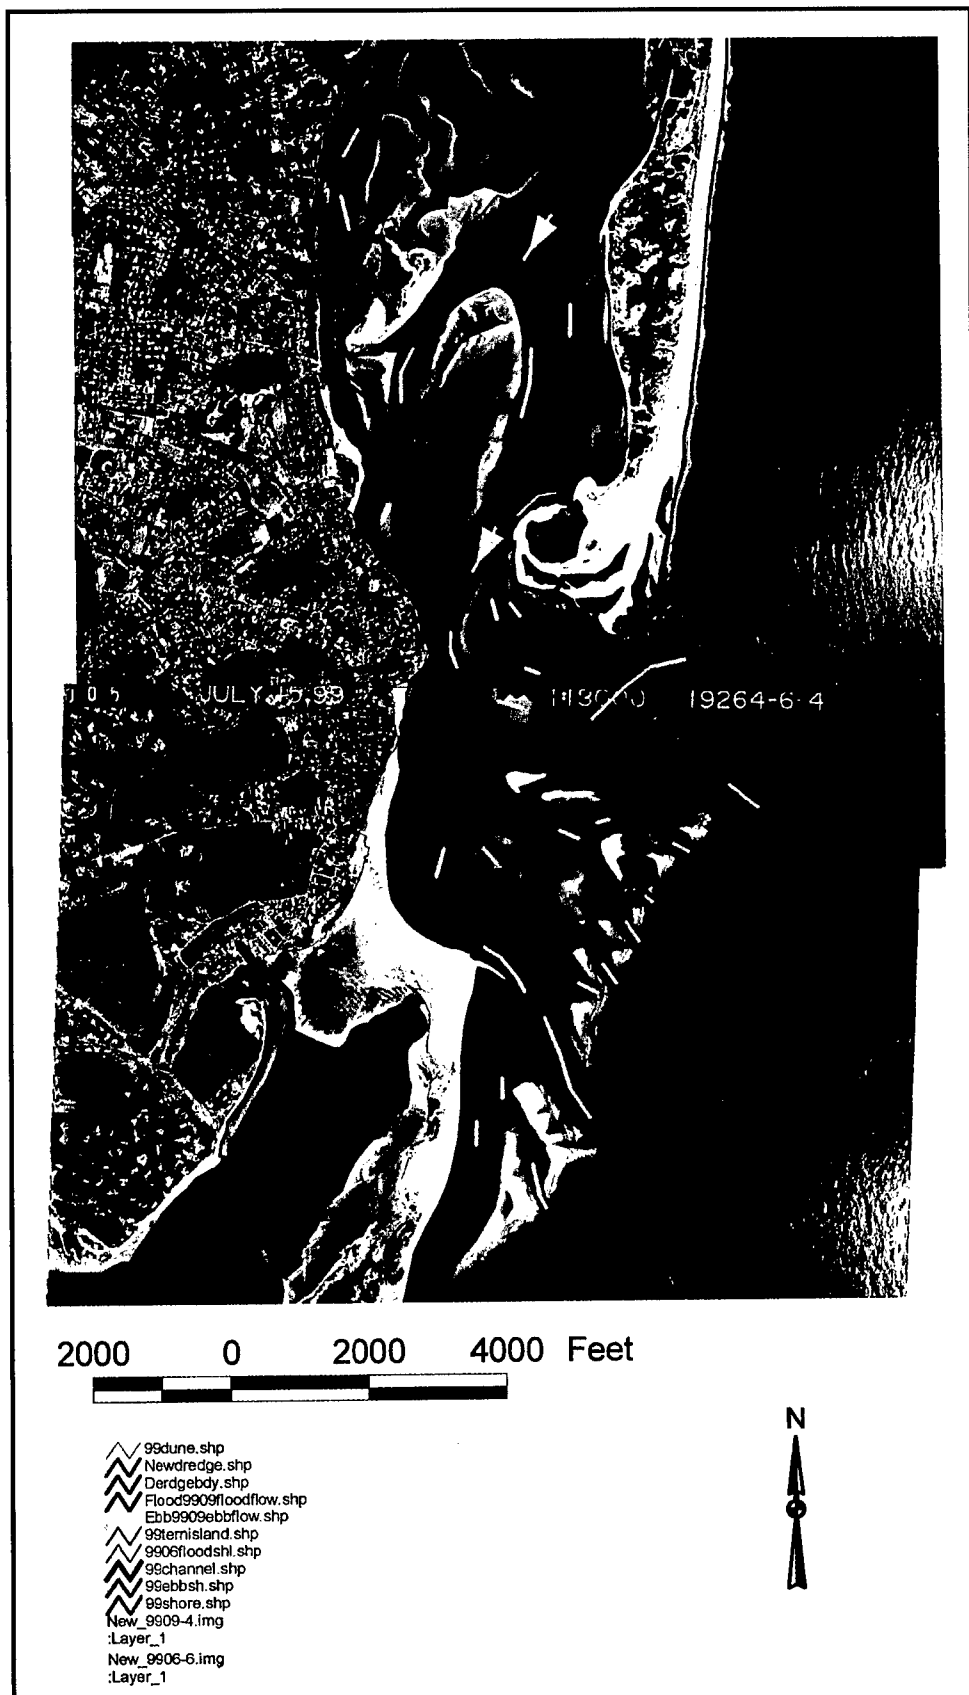
Figure 53. Sediment transport pathways based on morphology from July 1999

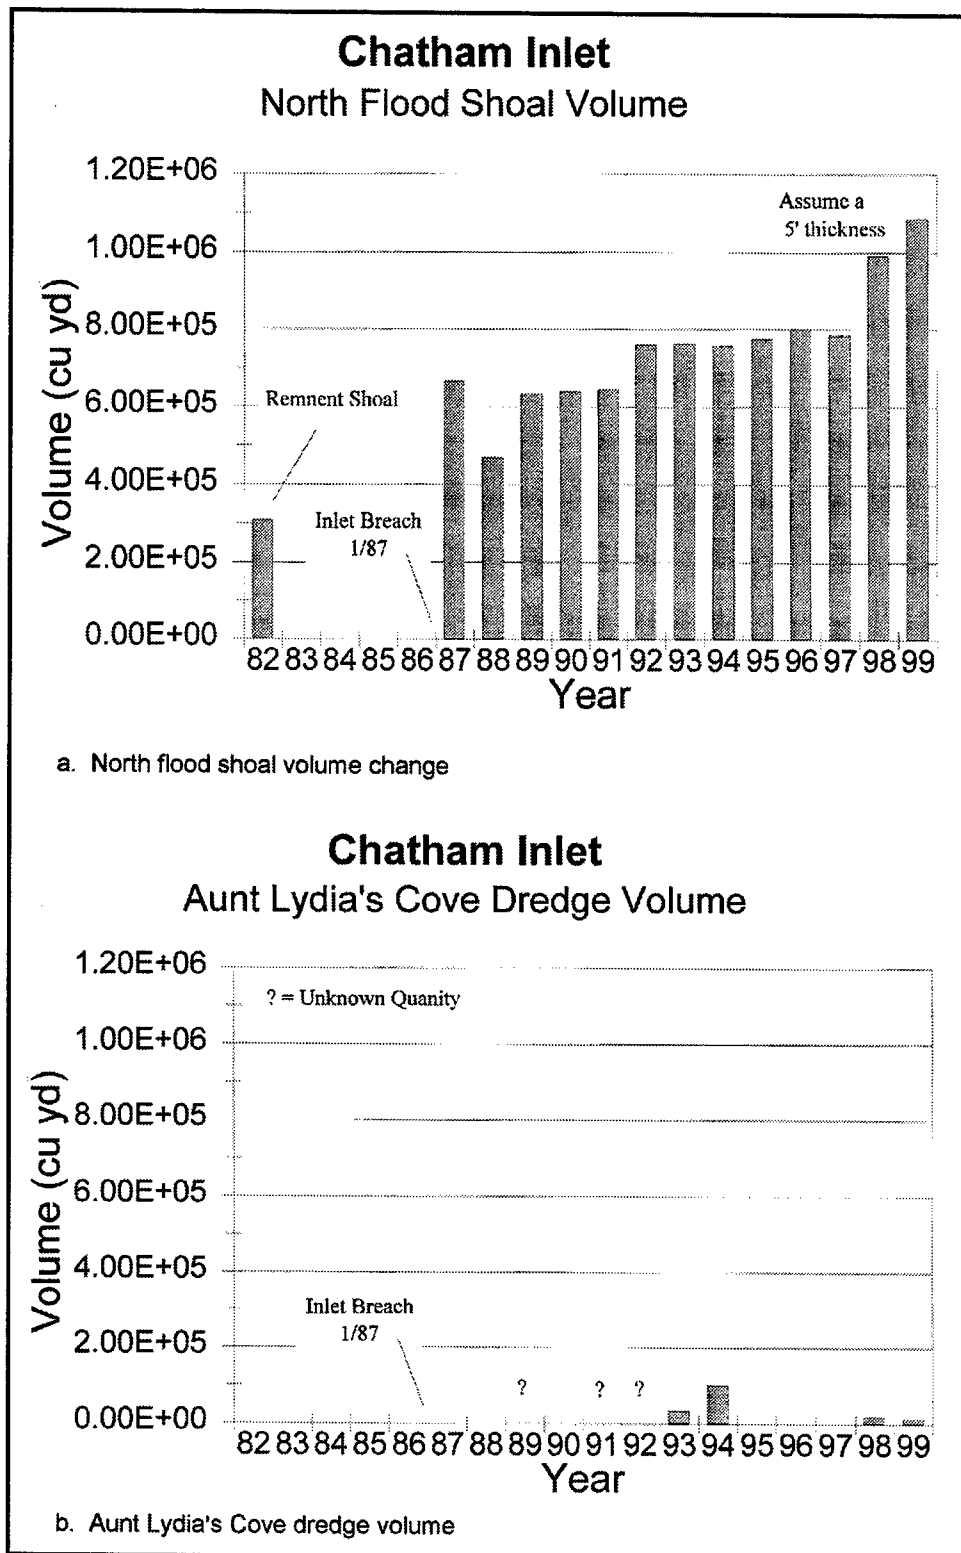
Figure 55. Comparison of north flood shoal volume change with volume of dredged material from Aunt Lydia's Cove (entrance channel and anchorage)
